## CHURCH OF OUR LADY OF GOOD HOPE

Fort Good Hope, North West Territories

### REPORT ON THE CONSERVATION AND RESTORATION

### OF THE PAINTED INTERIOR DECORATION

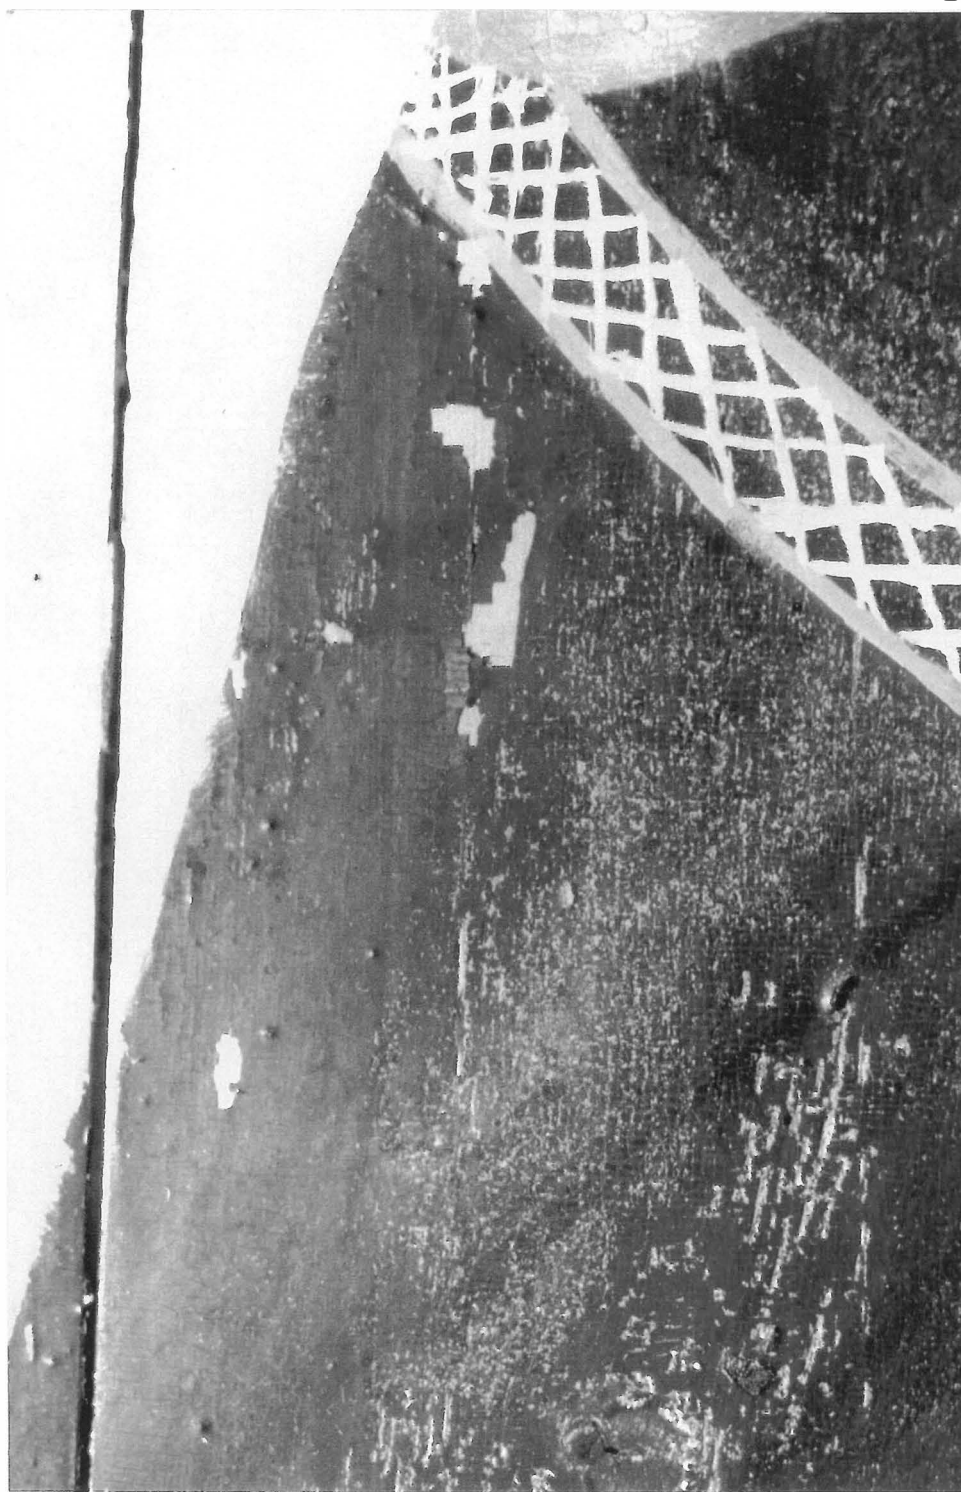
- .1 There are some areas of flaking paint on the painting of the Nativity/Adoration scene on the north wall of the chancel. These are the most serious areas of hazardous condition and will need extensive consolidation.

**FIG. 3**  
Detail from the Virgin's cloak, Nativity scene, north wall. Typical disintegration and flaking of paint.

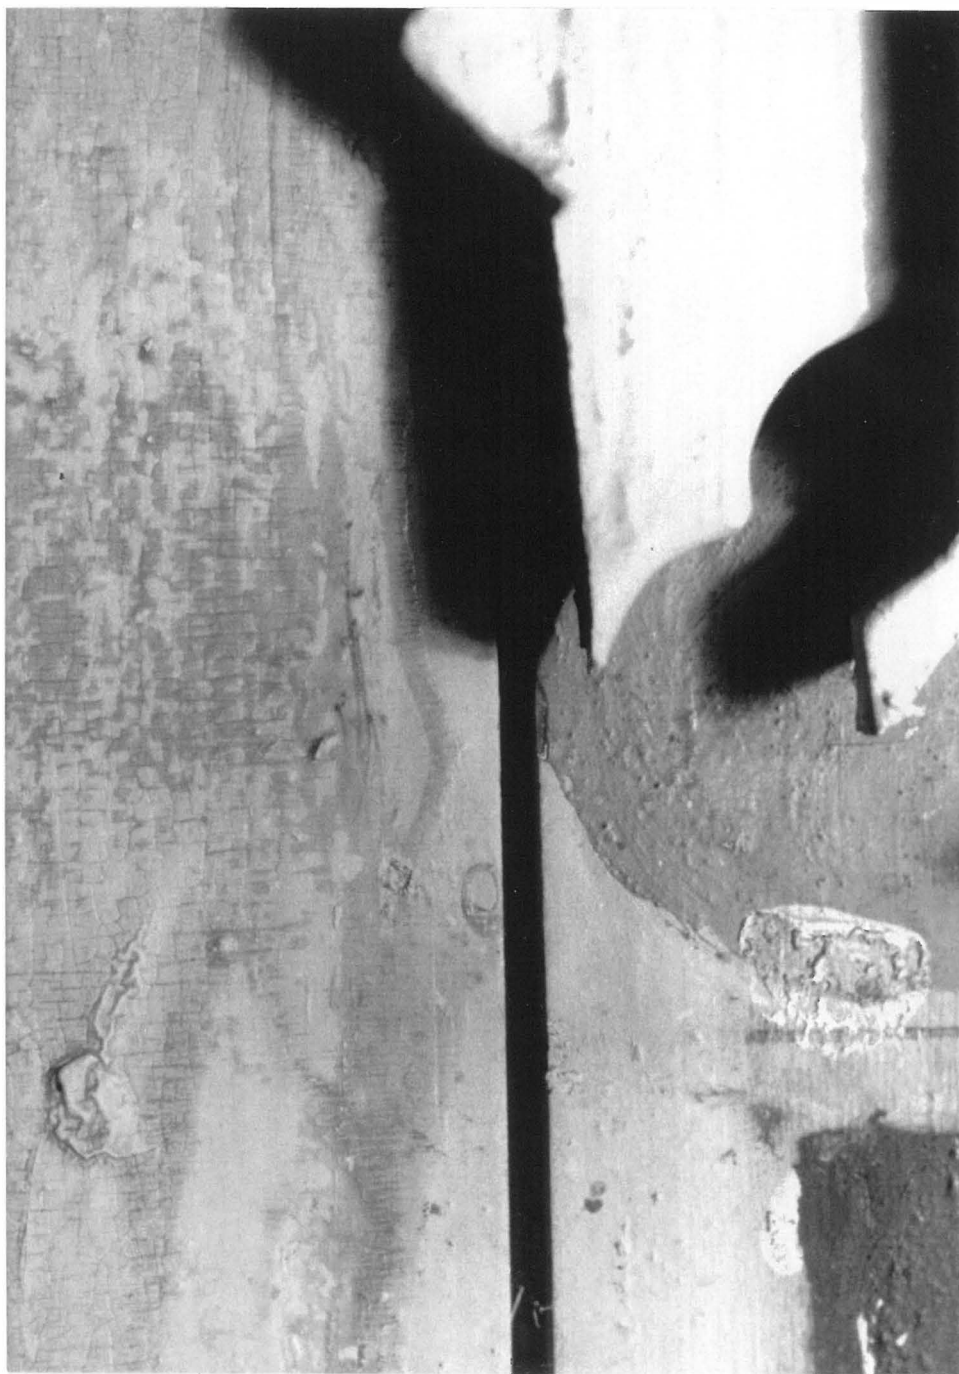
**FIG 4.**  
Detail from the south wall showing thick, uneven, discoloured varnish.

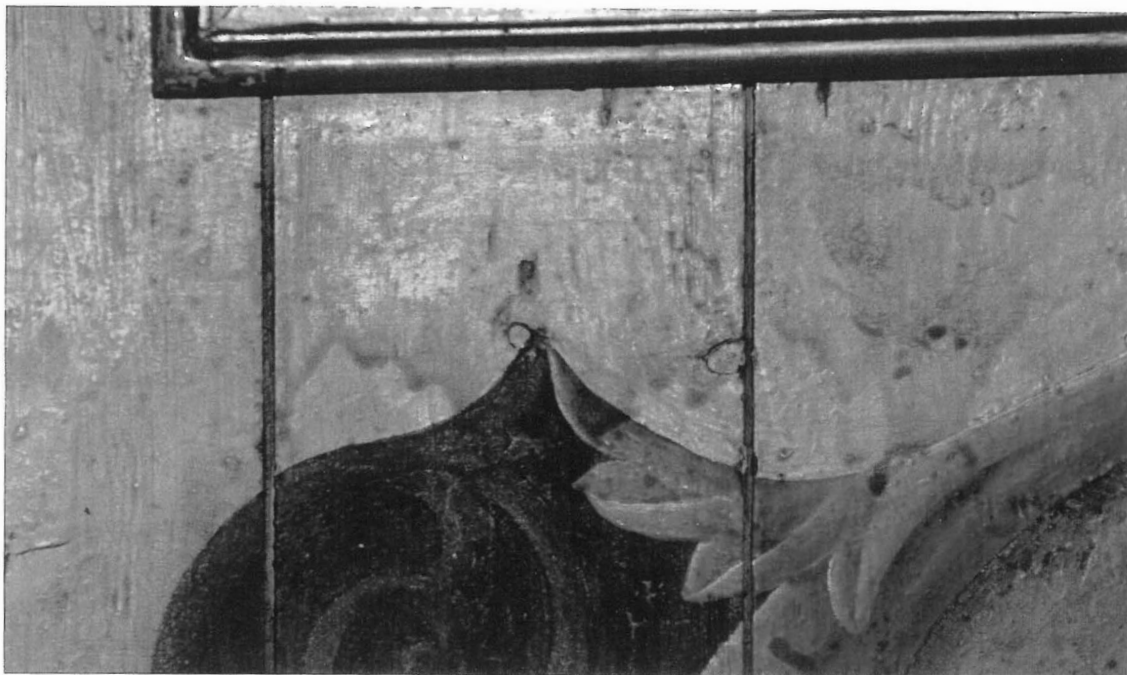
**FIG. 5**  
Another example of discoloured varnish.

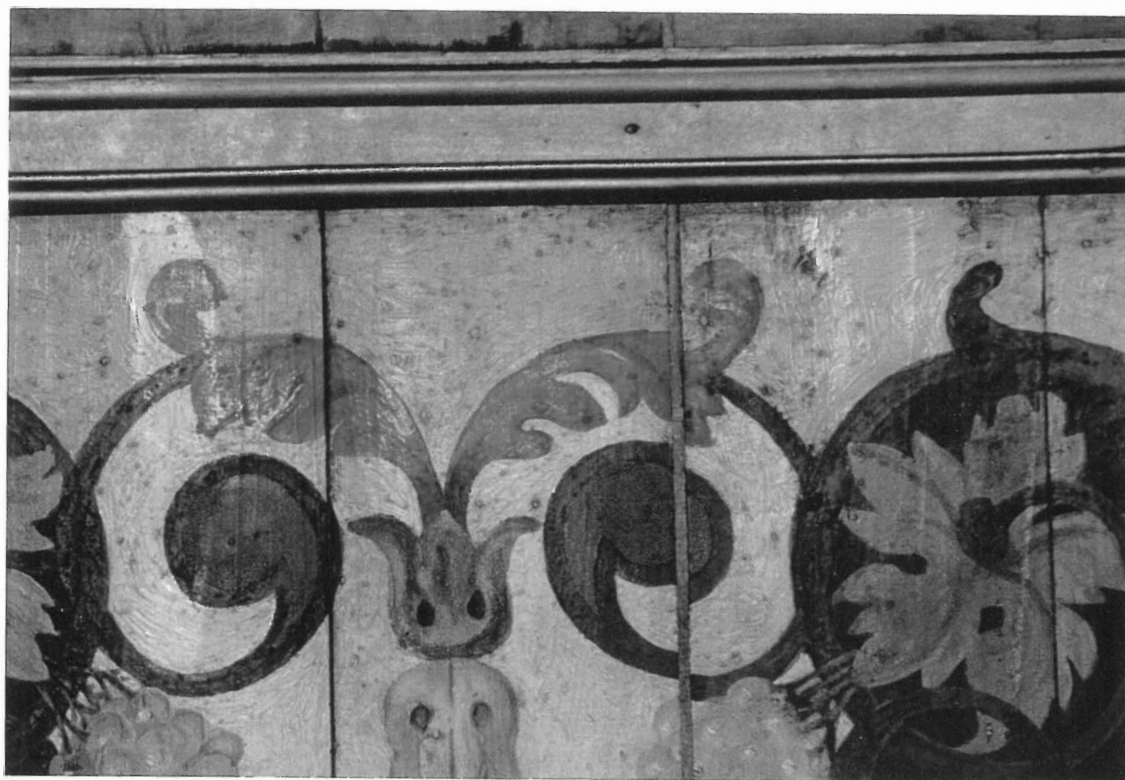
**FIG. 6**  
Test area for varnish removal.

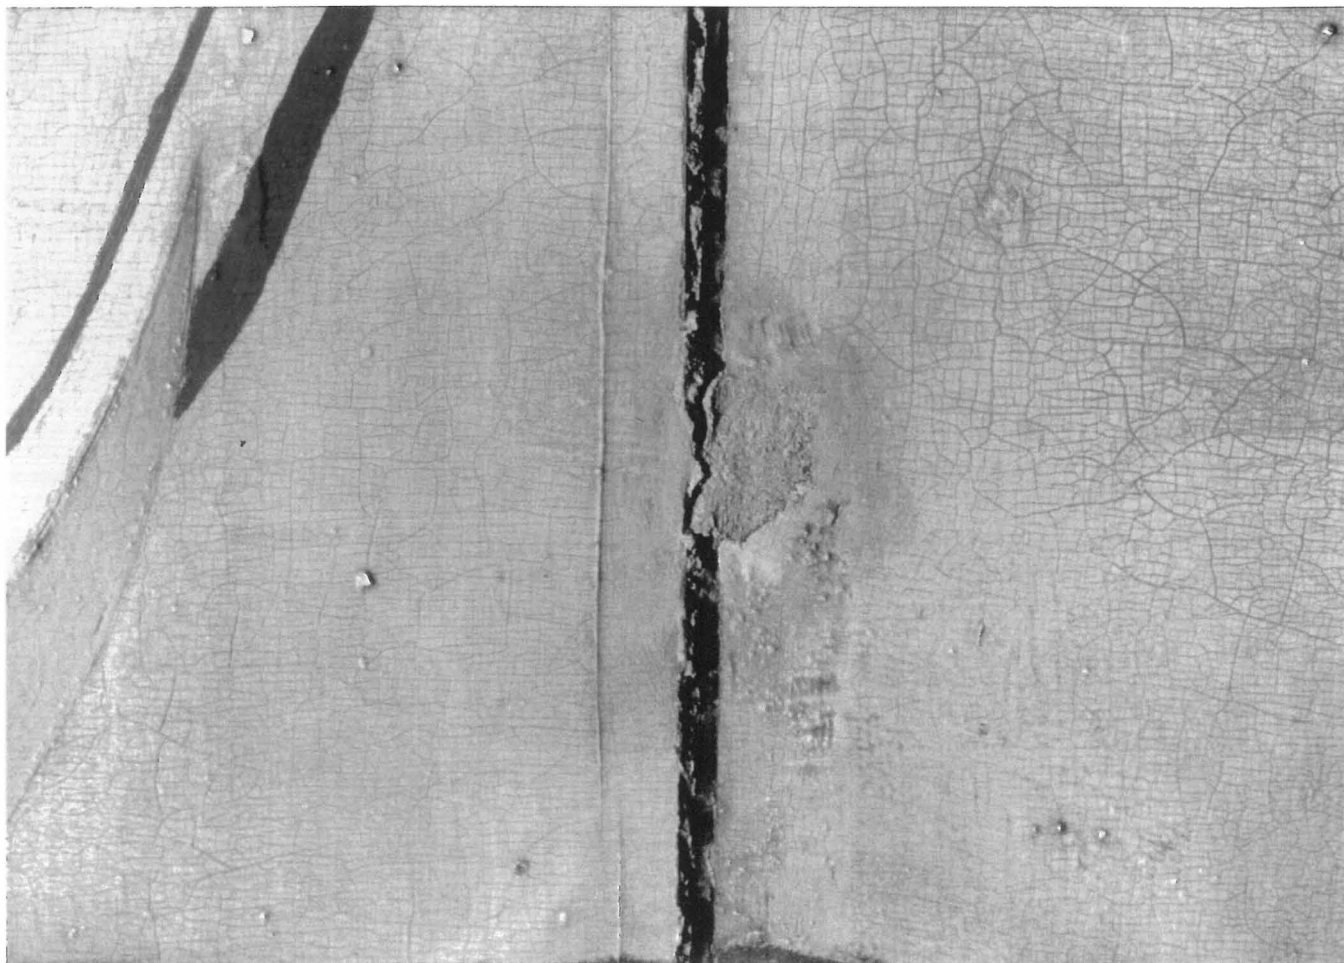
- .2 There are loose original fill materials at joints between boards on the Nativity on the north wall of the Chancel and especially on the scene of Our Lady of Good Hope on the south wall of the Chancel. This putty filler was put in place prior to the execution of the painting. The gaps occurred presumably as a result of green wood drying out and shrinking after its attachment to the walls.

**FIG. 7**  
Detail of a join between two vertical boards on the south wall of the Chancel.  
Note the damaged original putty fill between the boards and a later attempt to  
cover a nail head with "plastic wood".

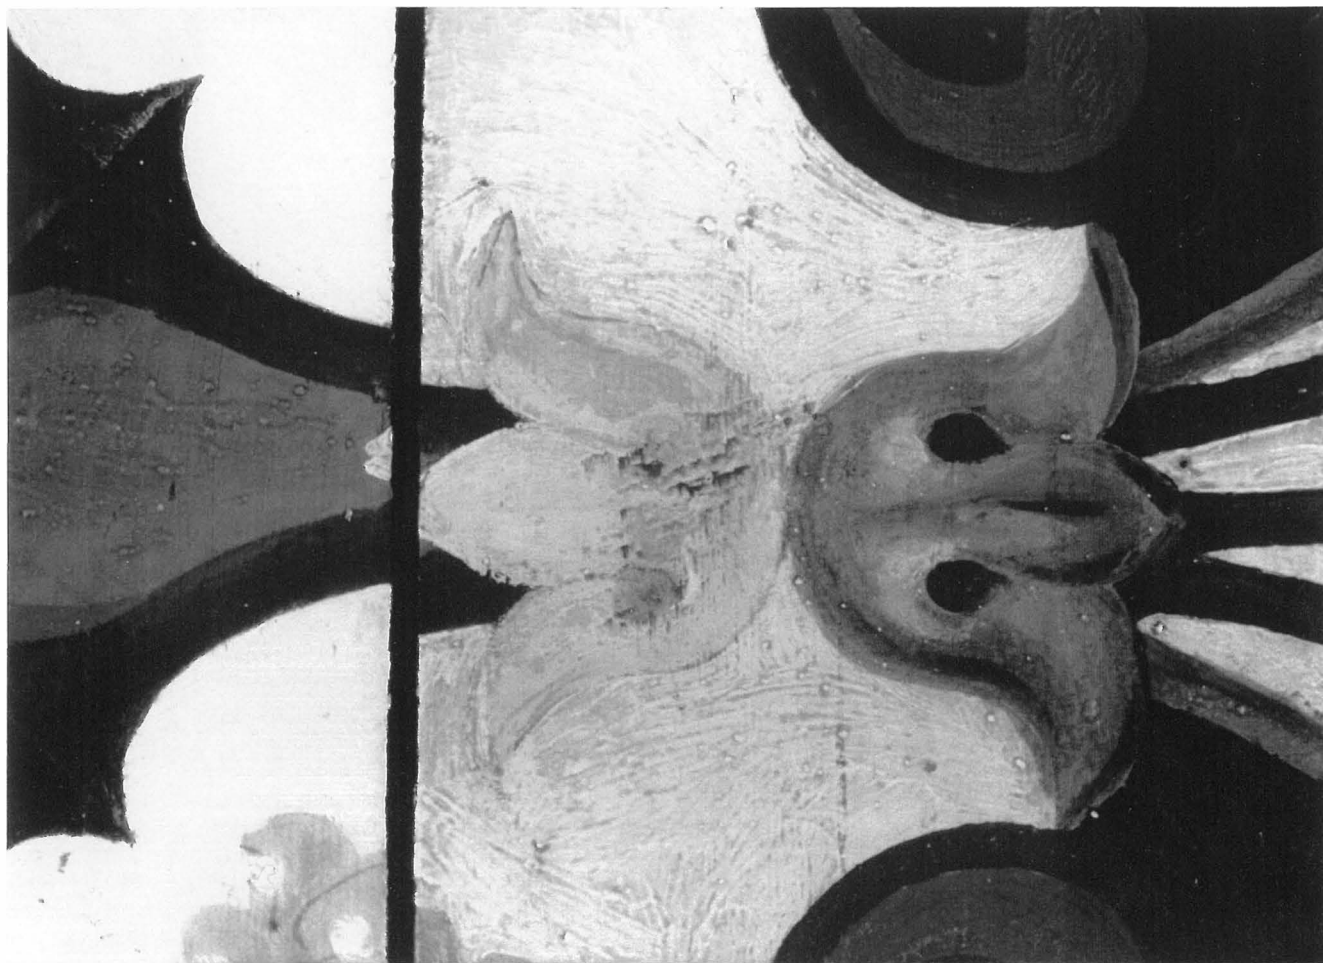
**FIG. 8**

Detail from Father Petitot's decorative painting on the north wall. The area on the left board has the discoloured varnish removed. Compare this with FIG. 9.

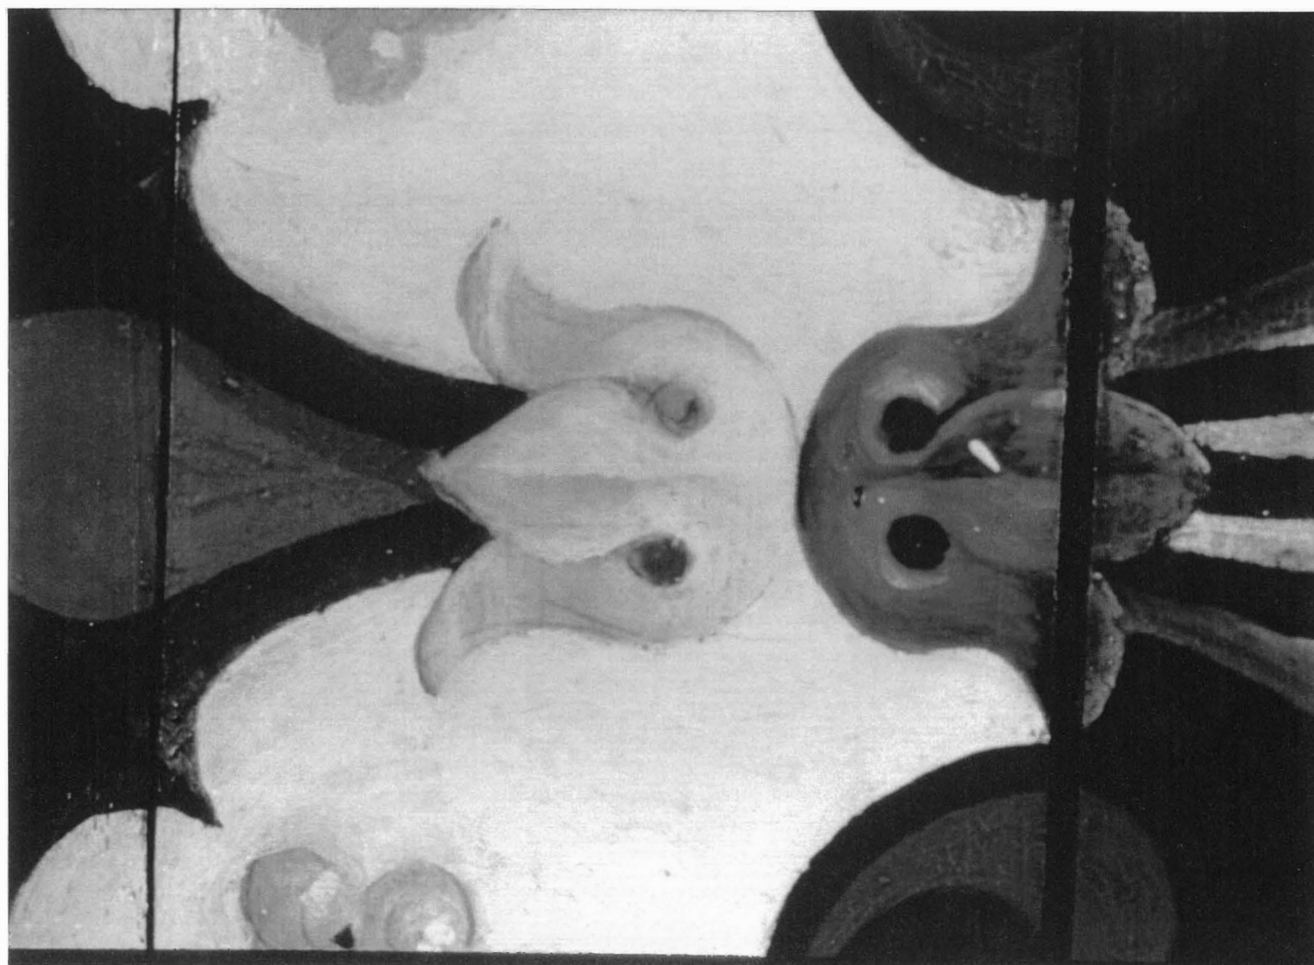
FIG 9.  
Detail from Father Petitot's decorative painting on the north wall. Here the discoloured varnish has been removed. Compare this with FIG. 8.

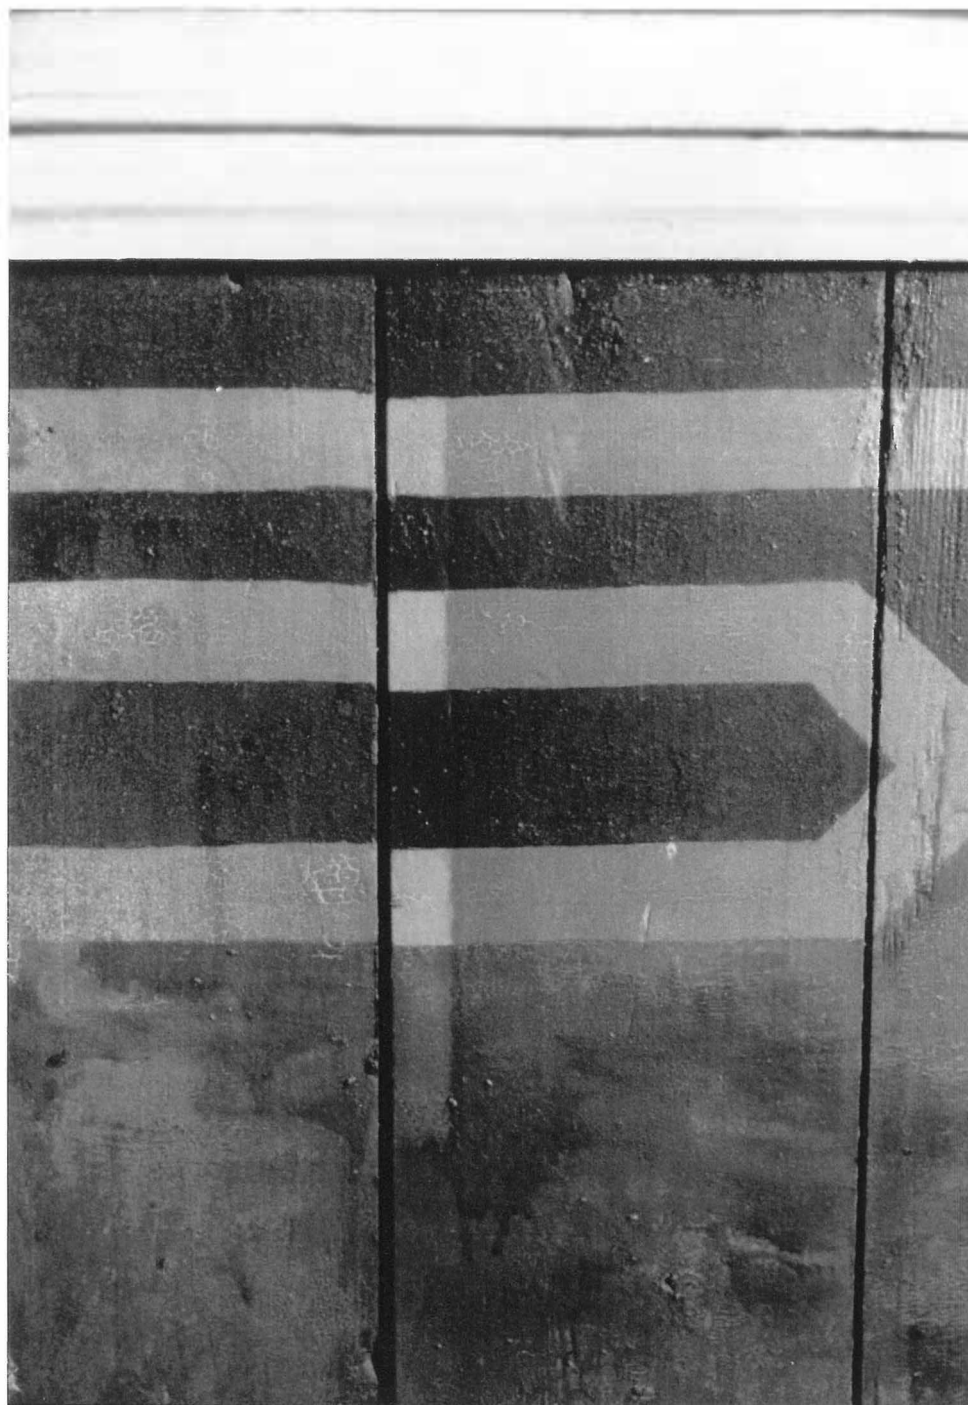
FIG. 10

Detail from the lower section of the south wall showing the effect of surface cleaning.

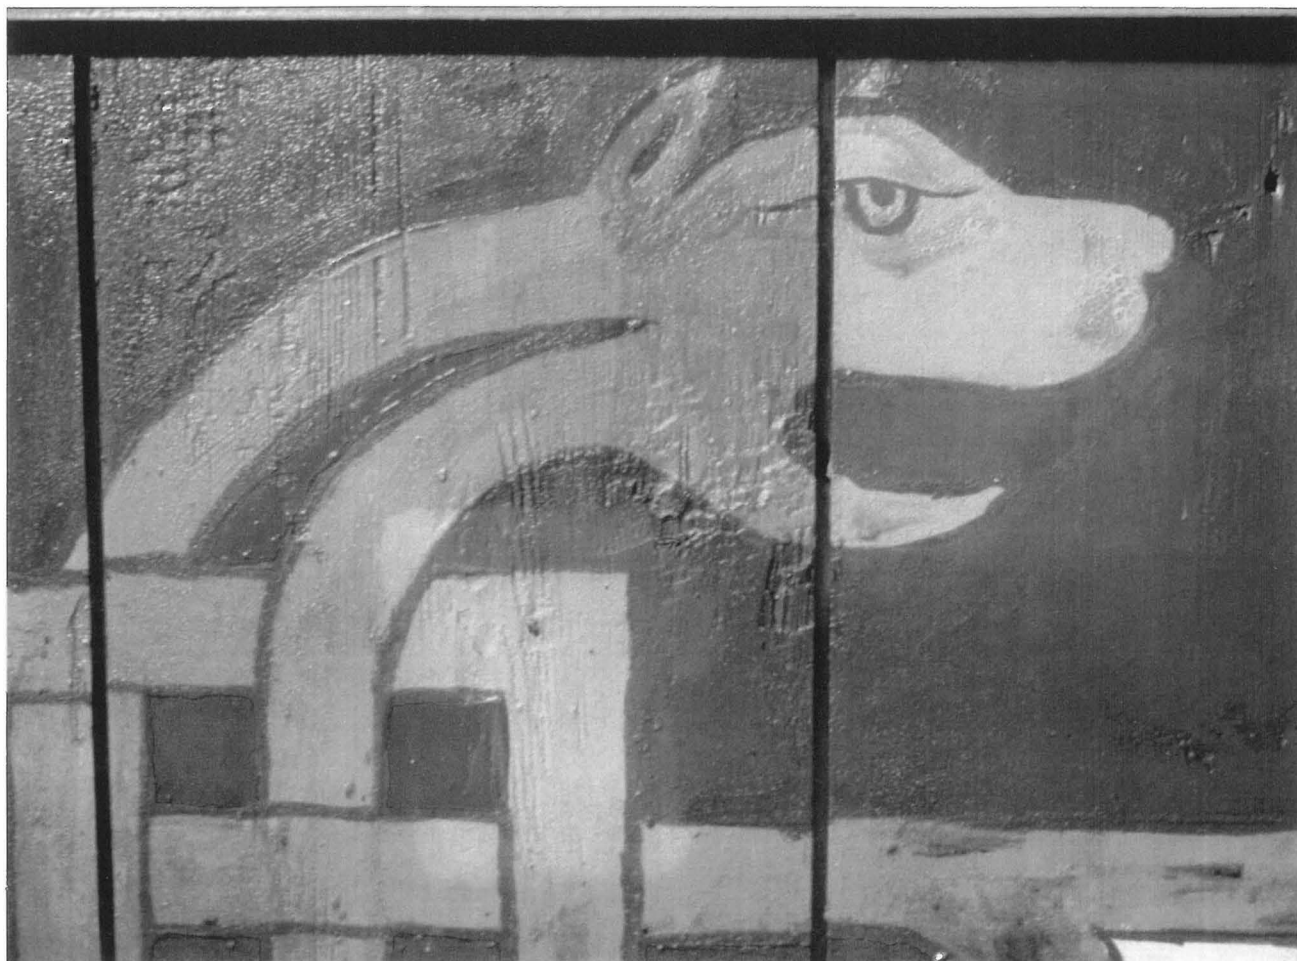
FIG. 11  
Detail on the lower wall of the Chancel showing the effect of surface cleaning.

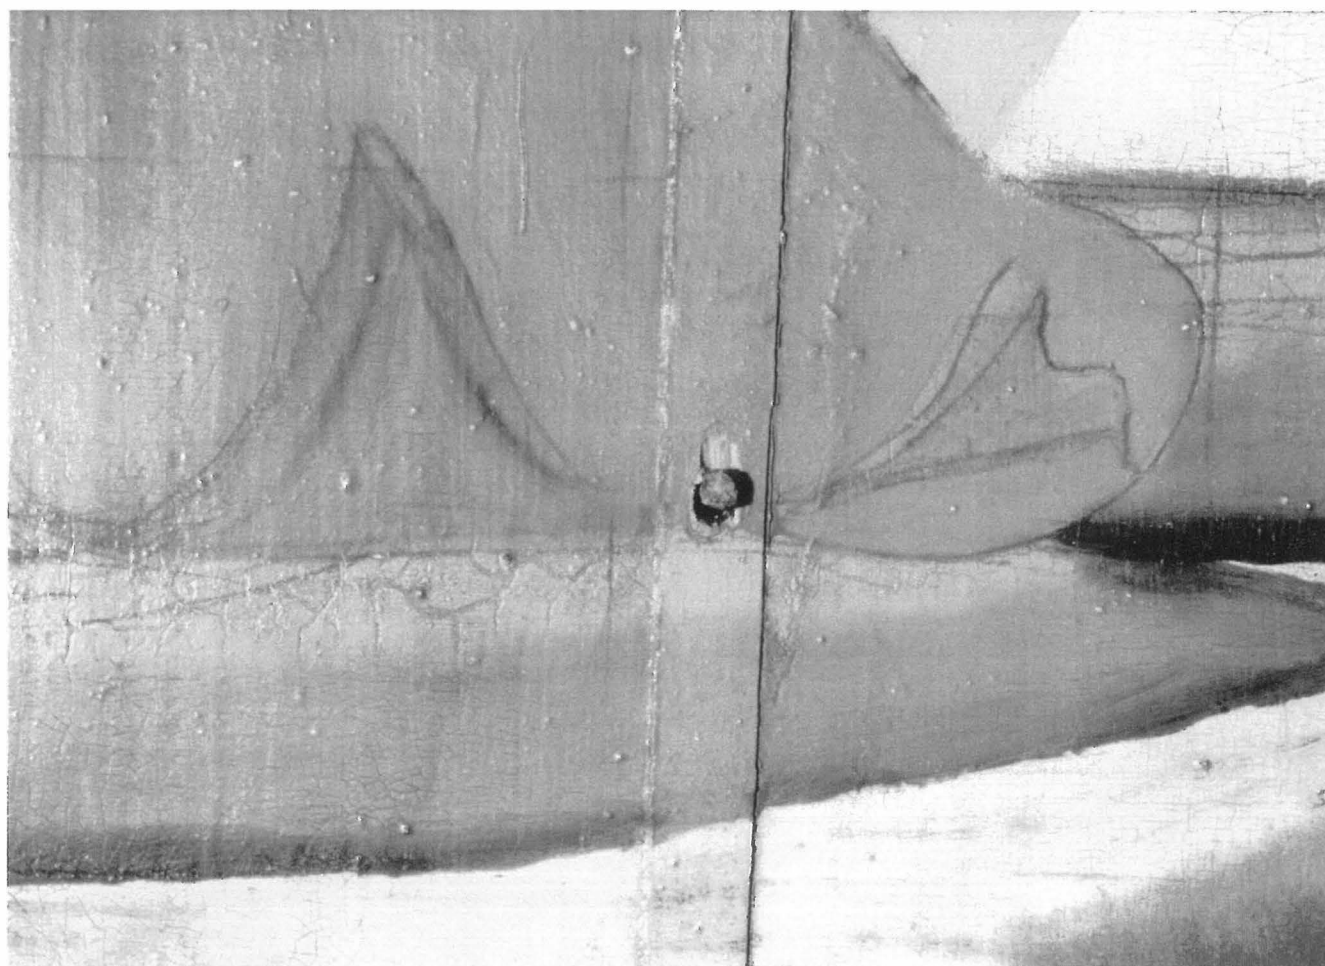
**FIG. 12**  
Detail from the Chancel, south wall showing a nail head which protrudes from the surface. This would be set, filled and retouched.

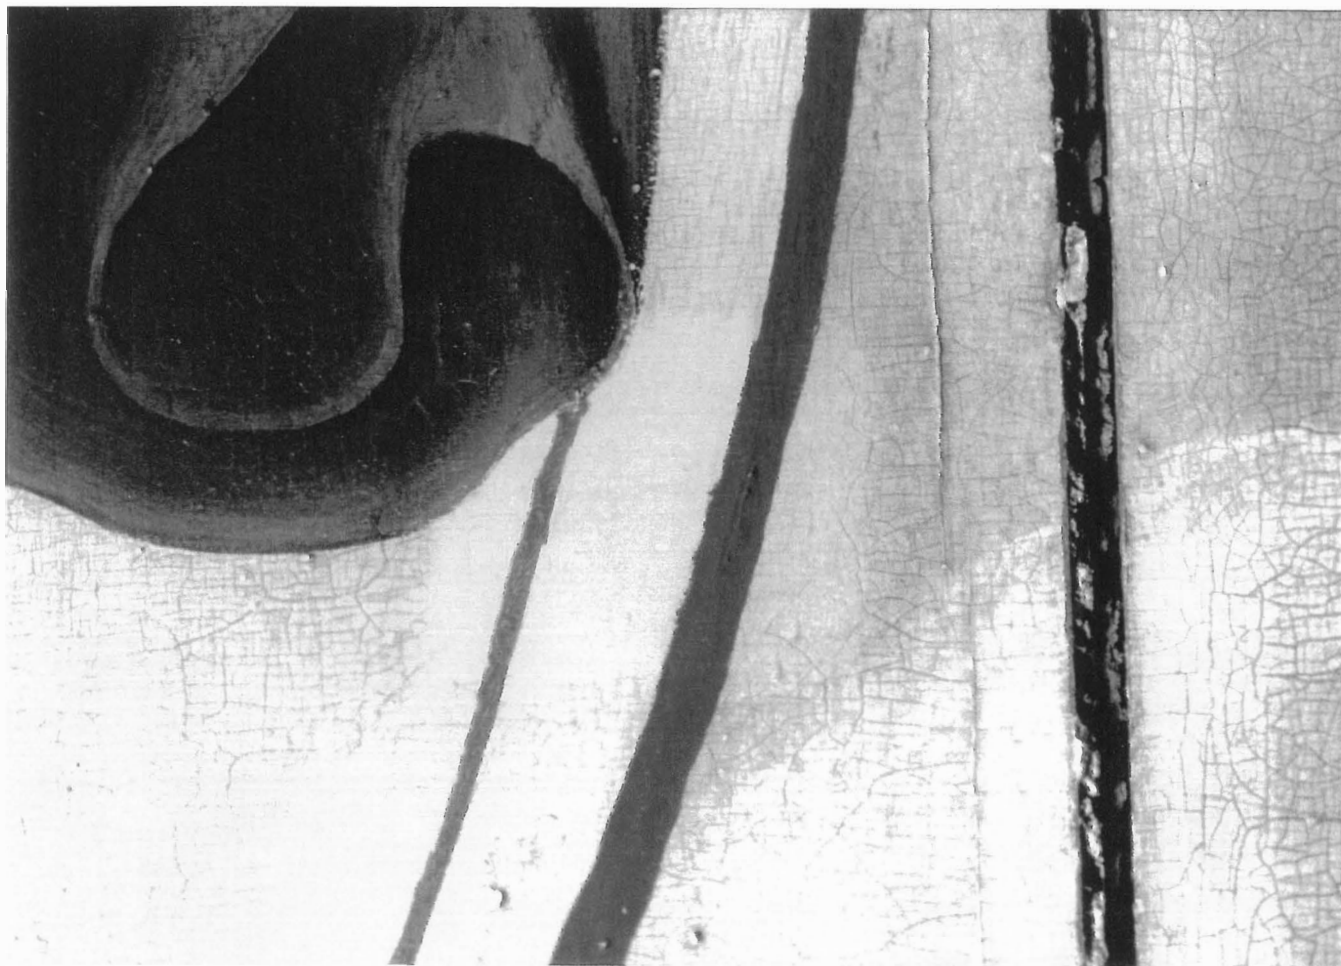
**FIG. 13**

Detail from the bottom of the cloak of Our Lady of Good Hope, (Chancel, south wall). This test shows that surface cleaning can remove all the grime embedded in the cracks.

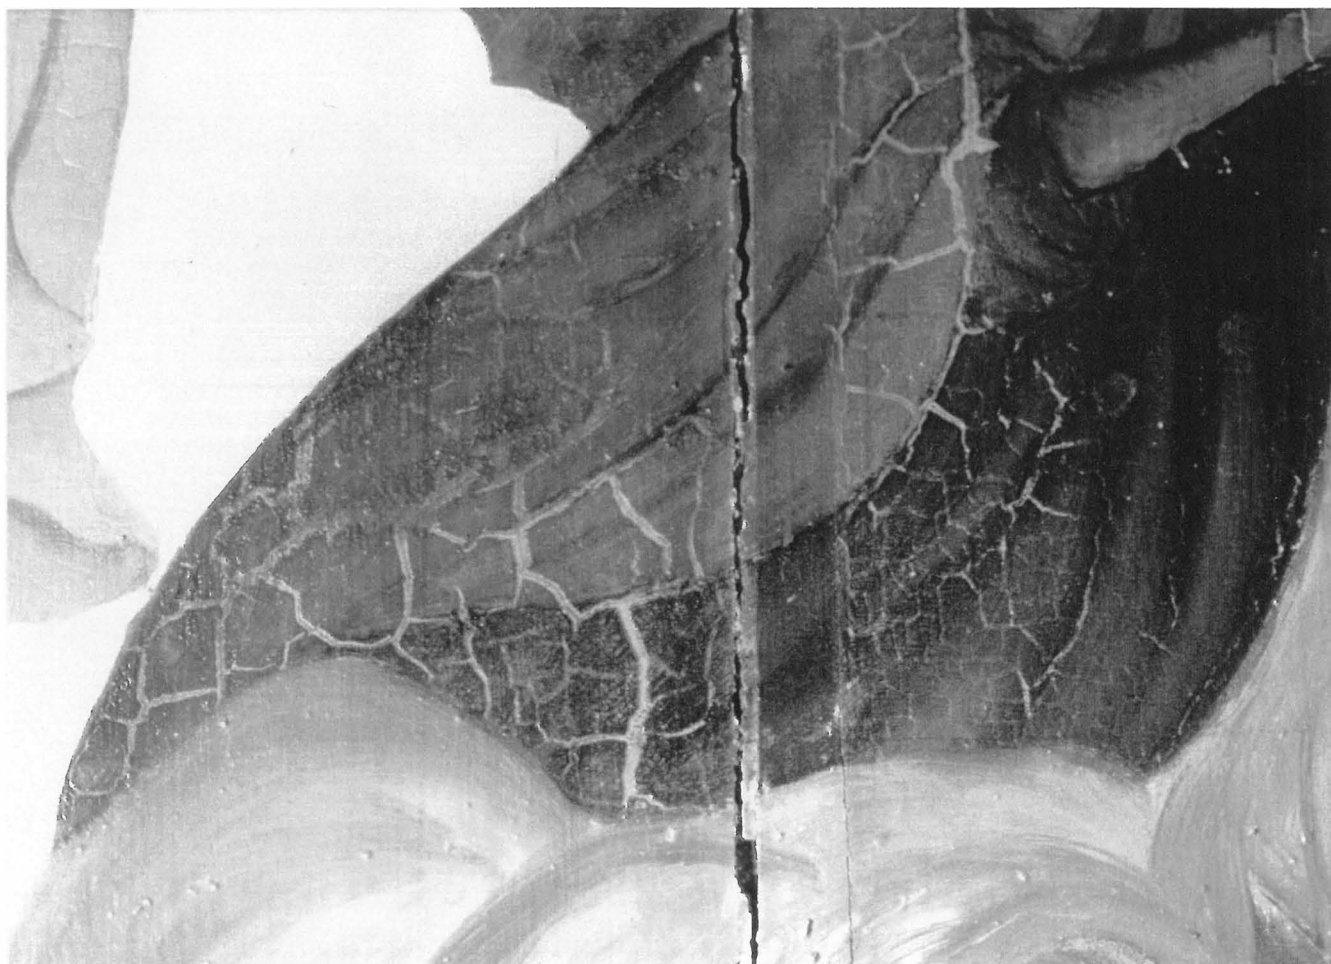
**FIG. 14**

Detail from the Chancel, south wall. This shows an area of original painted putty fill between boards. It also shows typical "alligator" cracking in the paint layers. The latter is an irreversible condition.

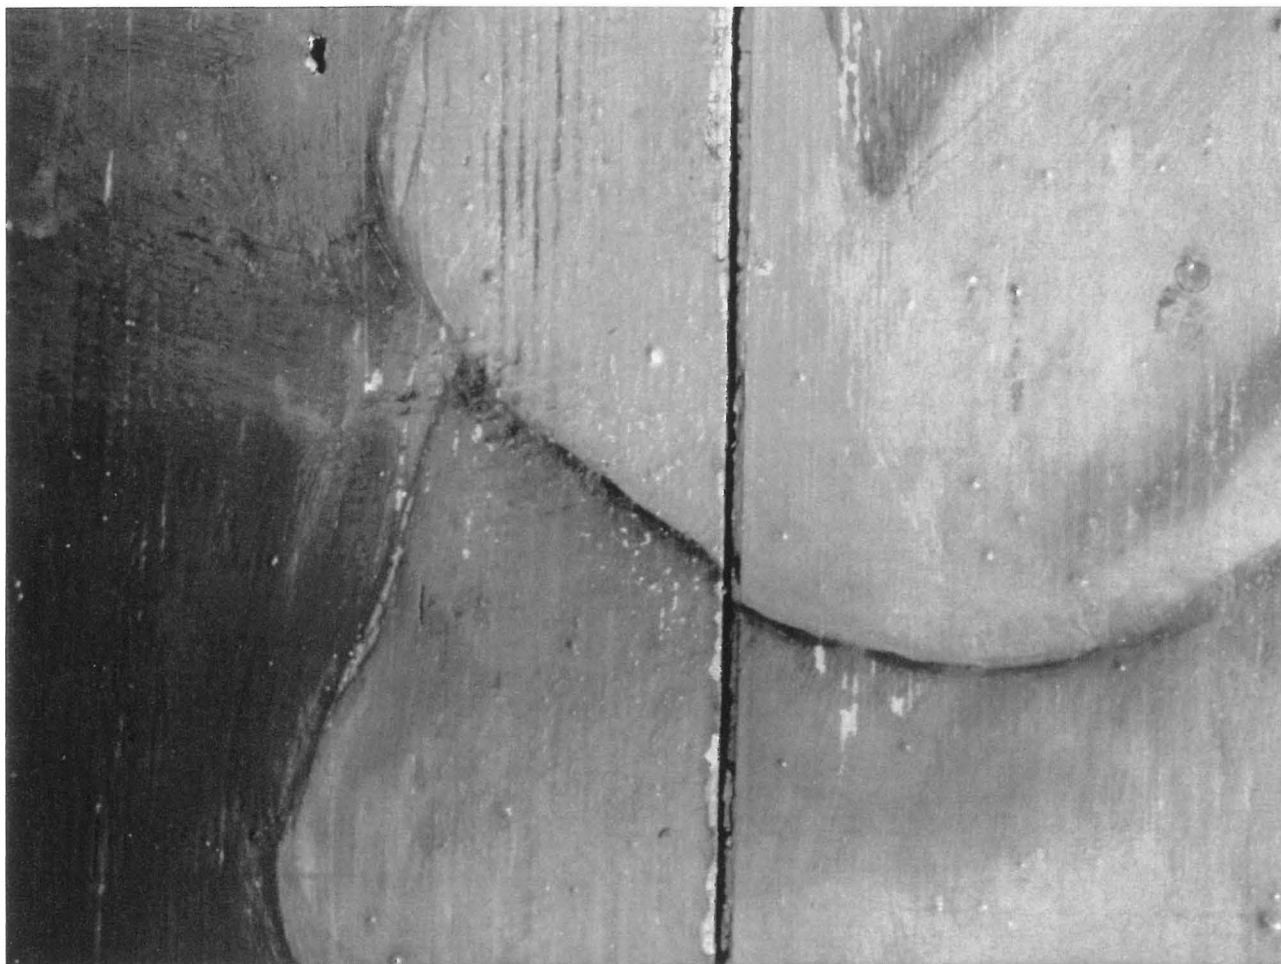
FIG. 15

Detail from the Chancel north wall. This shows some more flaking which requires consolidation. It also illustrates how surface cleaning brings out the true orange colour of the original paint surface.

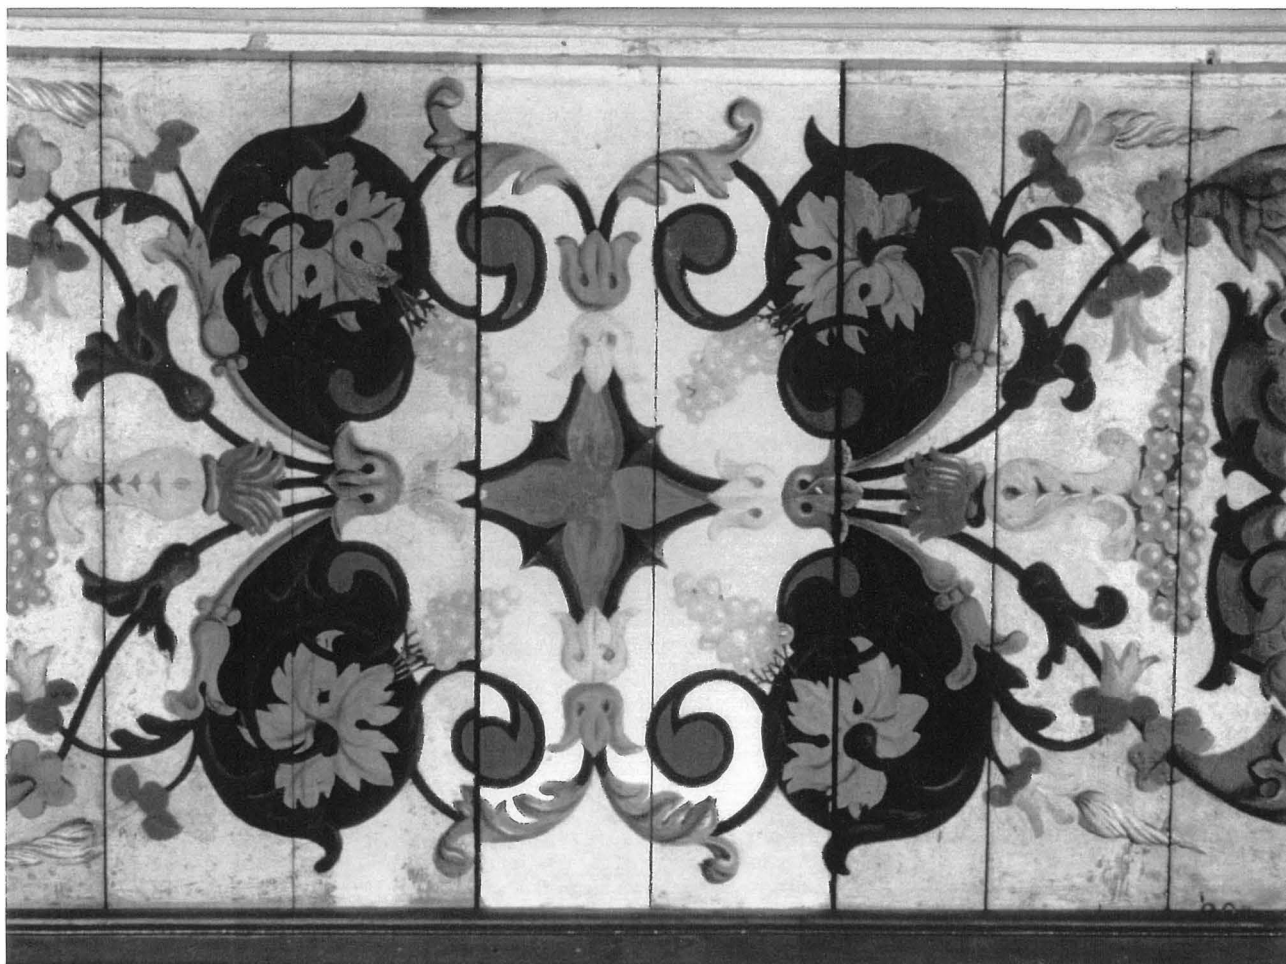
FIG. 16

Detail of Father Petitot's decorative painting on the north wall. The two central boards have had the discoloured varnish totally removed to reveal the vibrance of the original colour. This was a timed test for the purpose of calculating cost estimates.

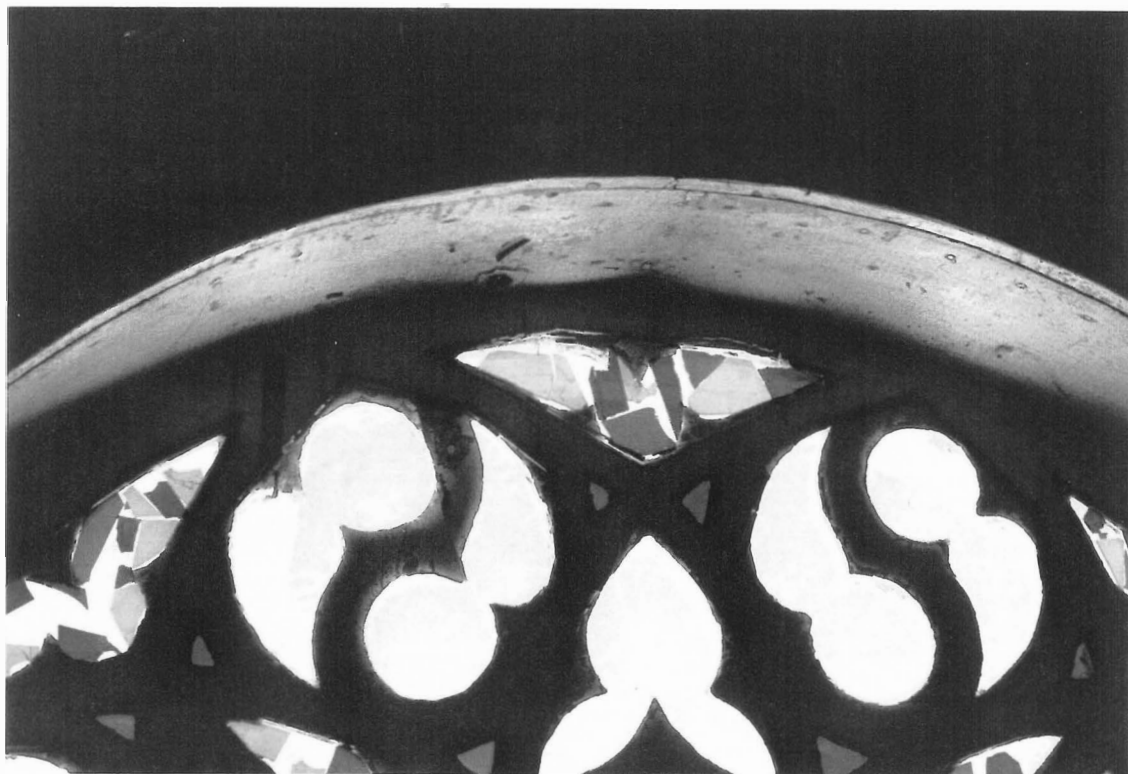
**FIG. 17**

Detail of a section of the Rose Window from the west wall. Fragments of coloured glass have been stuck to the surface of the glass in recent times with epoxy and silicone adhesives. These fragments may have come from the panes which are said to have been removed from the Nave windows.

- .5 Rose window, consolidate original wood where practicable, replace defective and missing parts with new parts carved to match the original. The latter to be painted to integrate visually with the original.

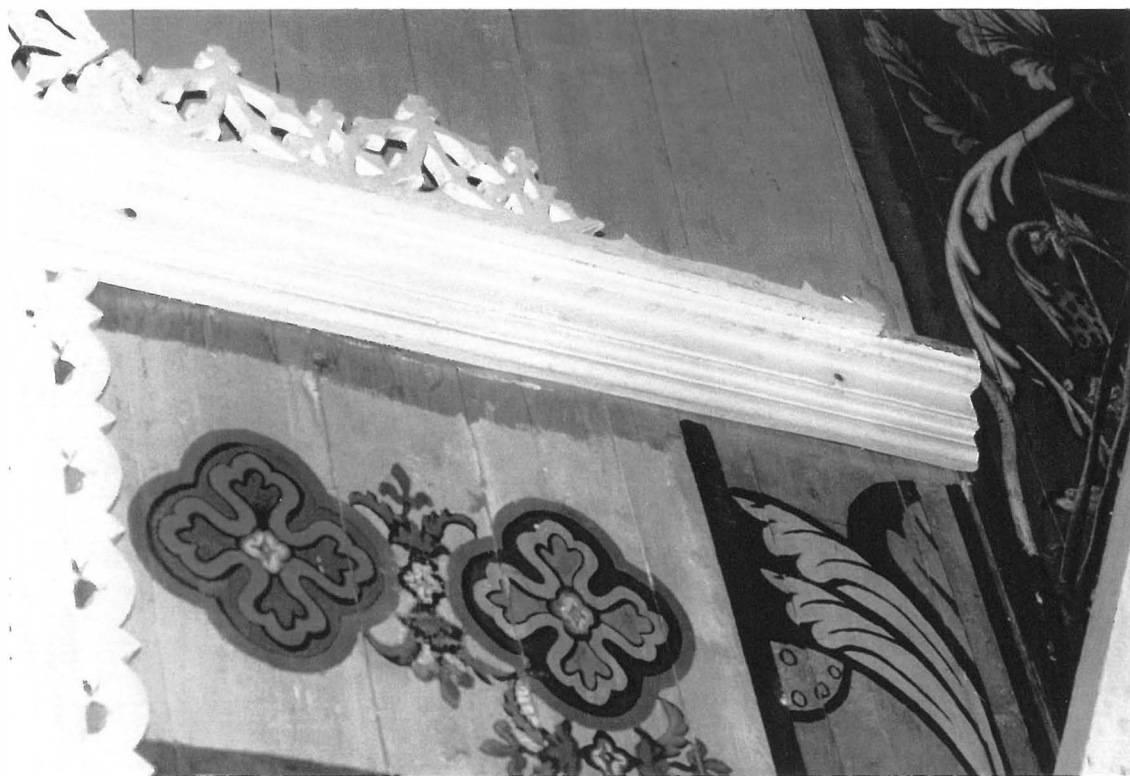
**FIG. 18**

Detail of the upper section of the west wall. This shows an unfinished area of the painted boards as well as a section of broken carved tracery.

- .4 Fretwork Tracery, new parts to be fabricated to match the original where parts are missing. The latter to be painted to integrate visually with the original.

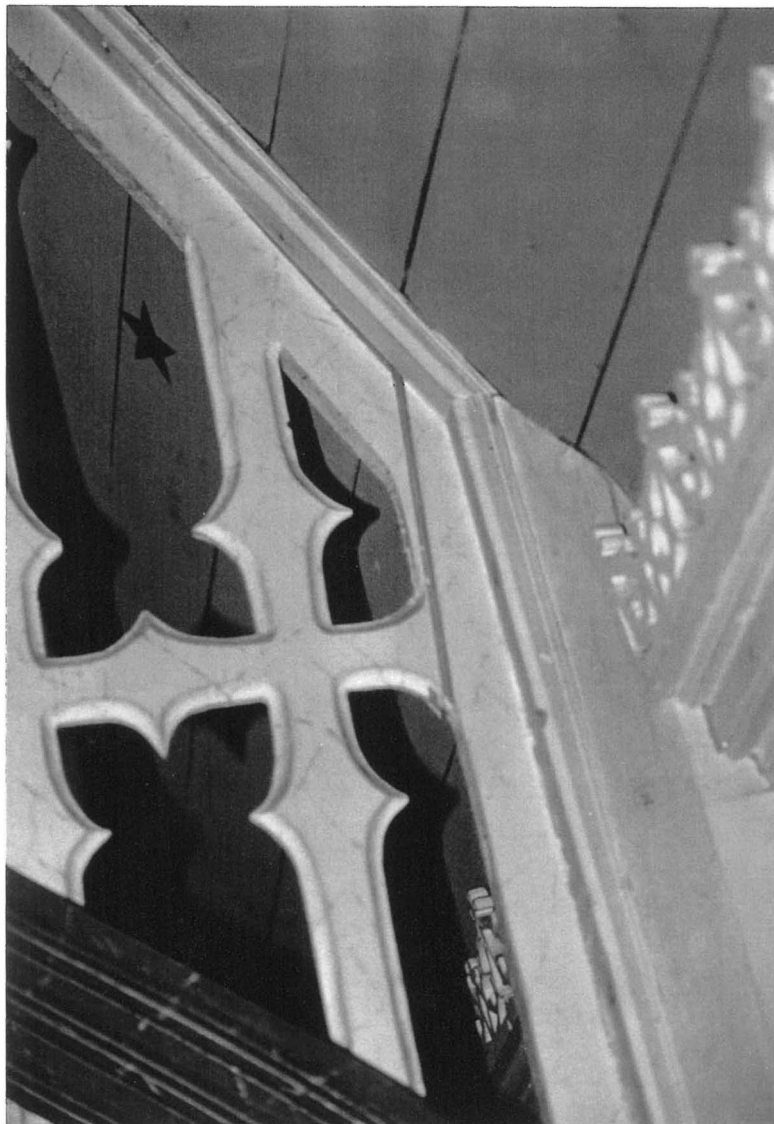
**FIG. 19**

In various locations there is evidence of movement in the building structure which reveals areas of unpainted wood in joints between boards and other structural members. It is here recommended that these be left as evidence of the natural behaviour of a building of this type in this location. This approach would be consistent with minimal intervention with the original work. The problem may be more than merely aesthetic. To judge from the scraps of cloth and other material which have been wedged into gaps in the structure, presumably by the congregation, there may be a serious draft problem. It remains to be seen to what extent the covering of the exterior with an air barrier will cure the condition.

Detail from the edge of the Tribune Arch where movement of the building structure has caused splits and revealed unpainted edges. Note also the blue veined *faux* marble finish which was once throughout the church. Compare FIGS. 20 and 21.

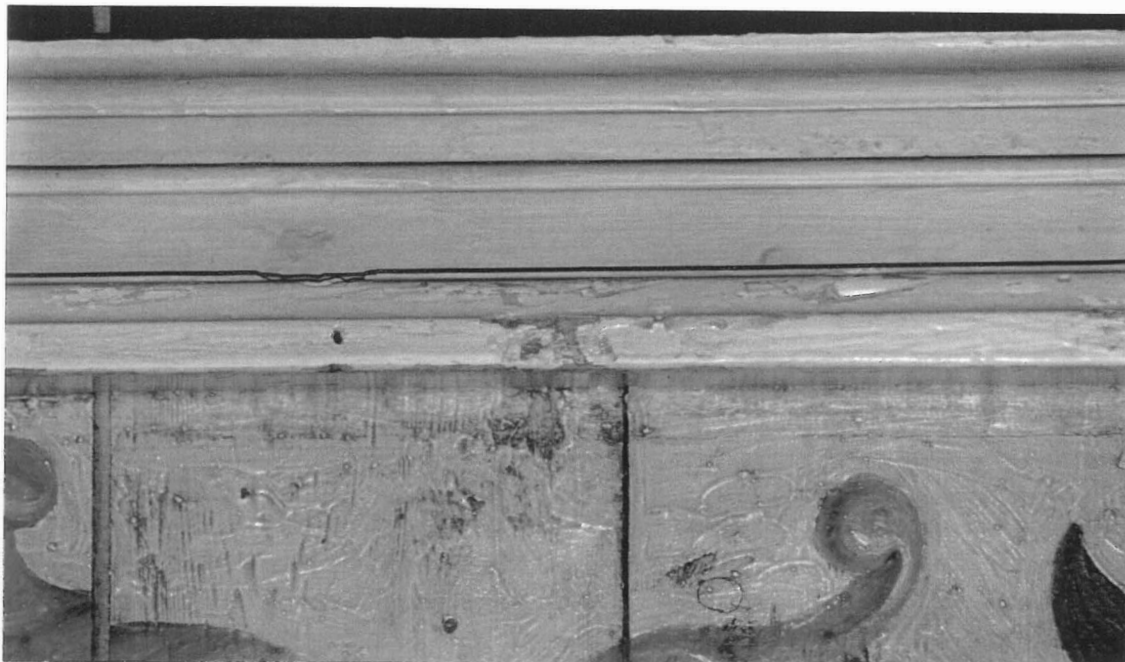
**FIG. 20**

Detail of the dado rail showing vestiges of underlying *faux* marbling.

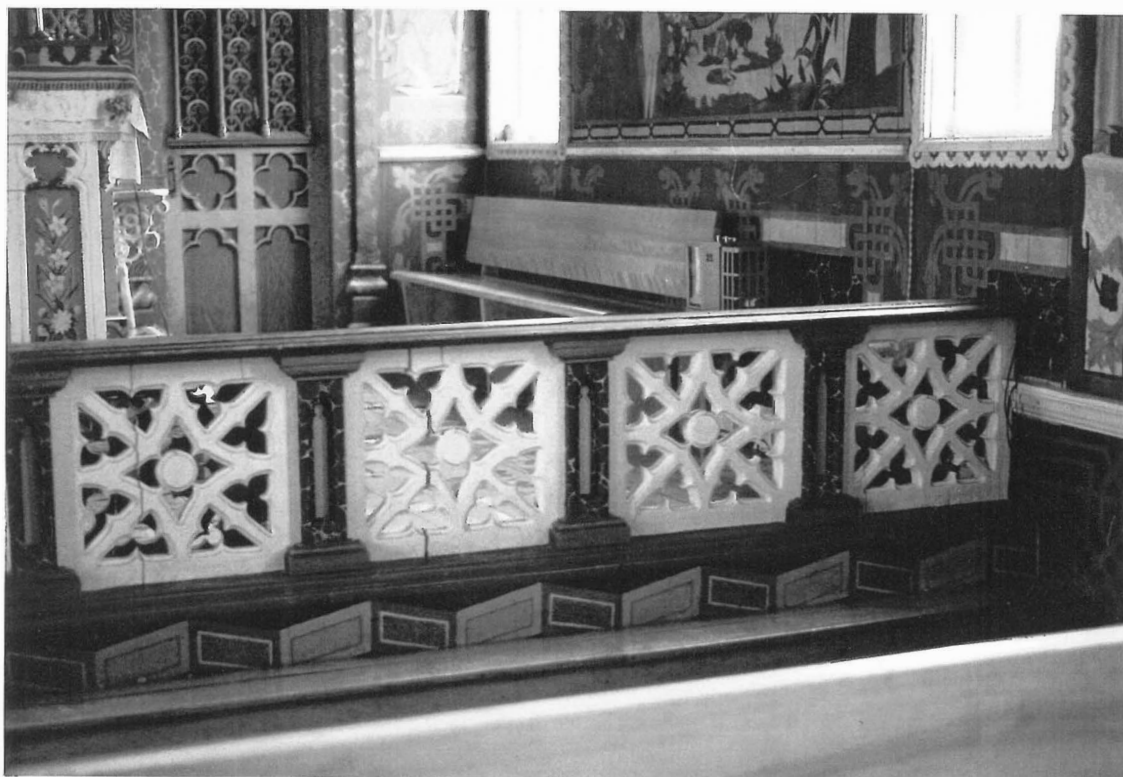
**FIG. 21**

Detail of the Altar Rail. The white painted and carved tracery was once finished with blue-veined false marbling. Compare FIGS. 19 and 20.
