## CHURCH OF OUR LADY OF GOOD HOPE

Fort Good Hope, North West Territories

### REPORT ON THE CONSERVATION AND RESTORATION

### OF THE PAINTED INTERIOR DECORATION

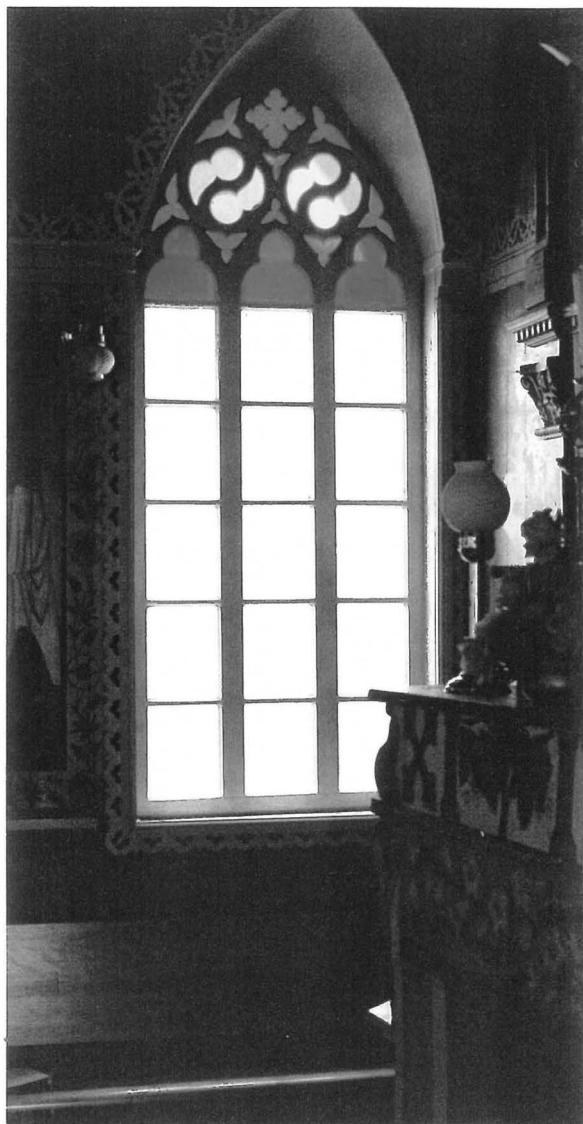
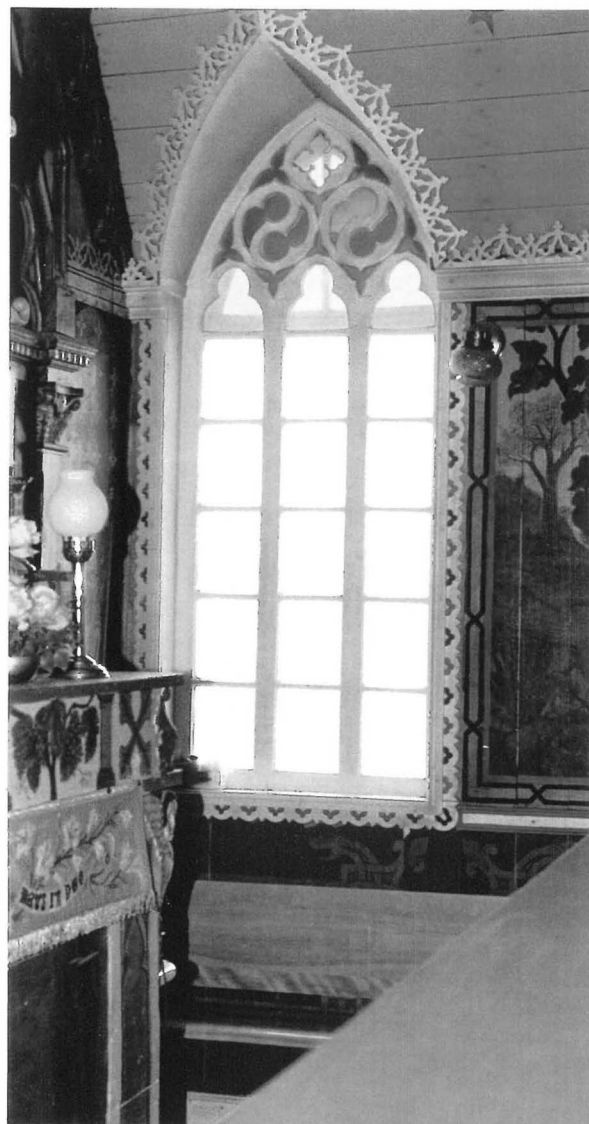
FIG. 22  
Chancel window, north wall.

FIG. 23  
Chancel window, south wall.

Note how the colour disposition varies.

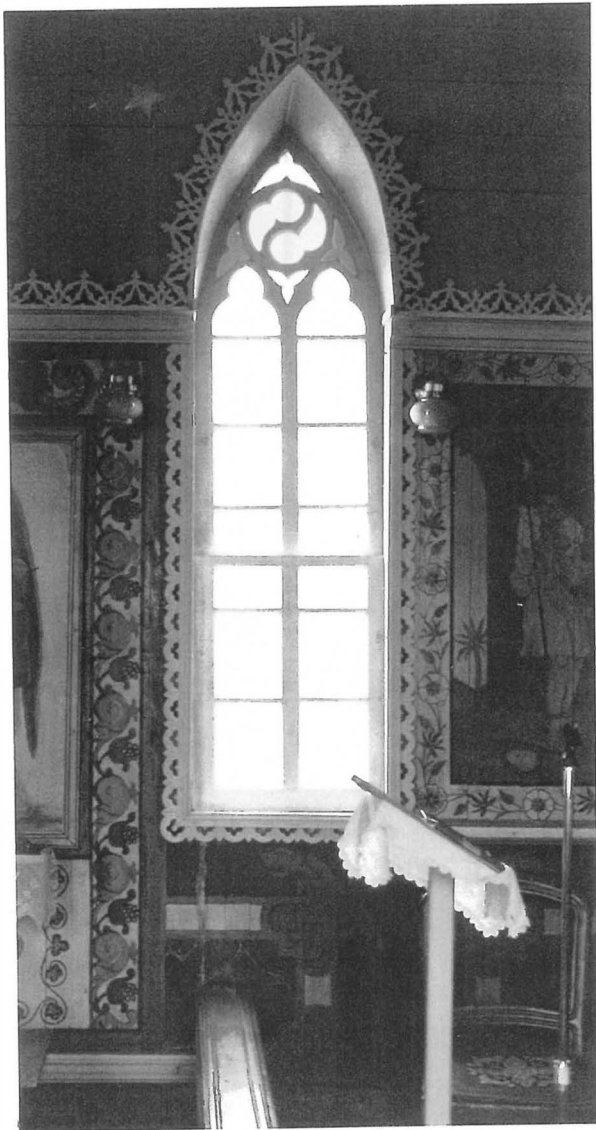
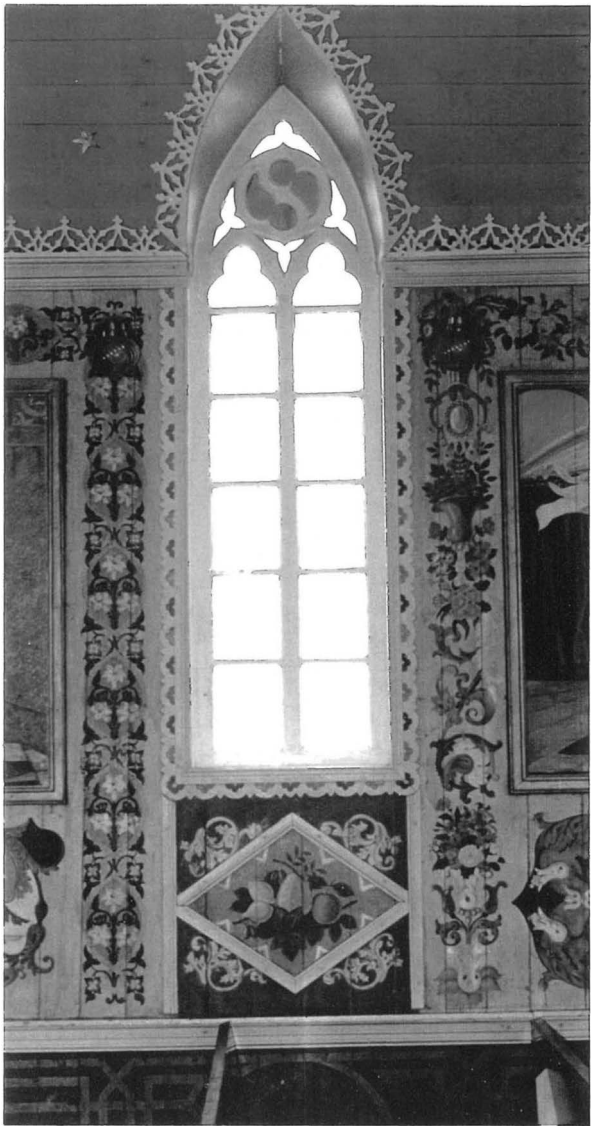
FIG. 24  
Typical Nave window, north wall.

FIG. 25  
Typical Nave window, south wall.

Note how the colour disposition varies.
